Golder Associates Inc. Denver, Colorado			TITLE EXPLANATION OF CROSS-SECTIONS		
CLIENT/PROJECT DACWPF PART B POST-CLOSURE PERMIT APPLICATION			DATE OCT 1989		SCALE
DRAWN BDL			CHECKED LTZ		REVIEWED
FILE			DWG. NO.		FIGURE D-8
JOB NO. 893-2191.2

DACWPF

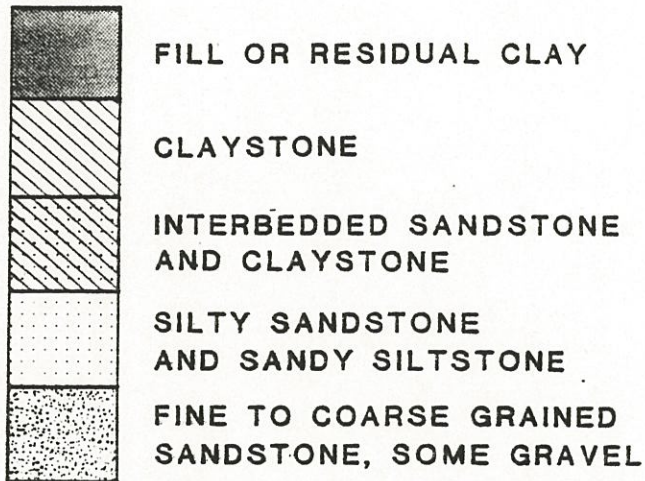
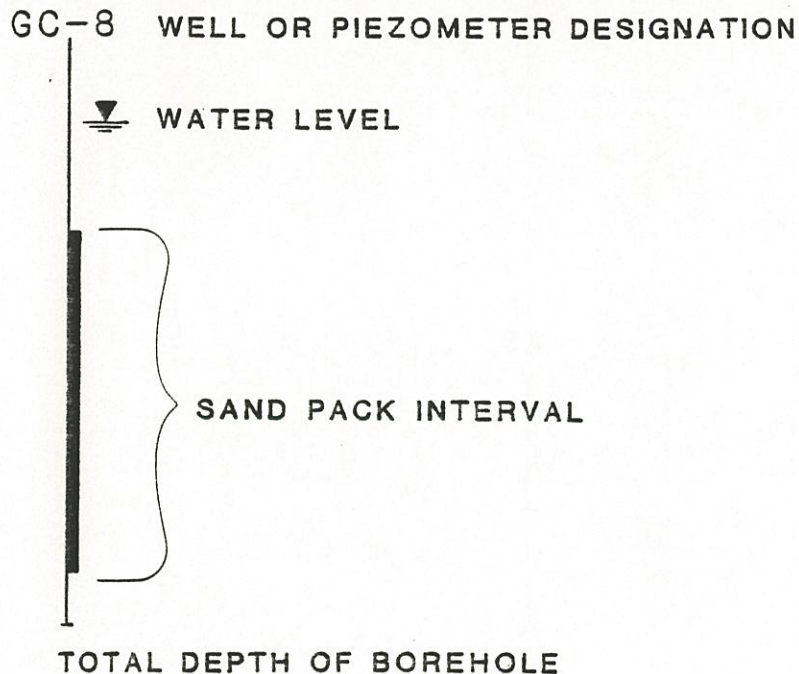
GEOLOGIC MATERIALS

The geologic materials depicted on cross sections indicate the predominant rock type within a given sequence. A rock sequence identified as CLAYSTONE may contain relatively thin units of coarse-grained materials. Similarly, a sequence identified as SANDSTONE may contain claystone or siltstone layers.

WELL/PIEZOMETER COMPLETIONS

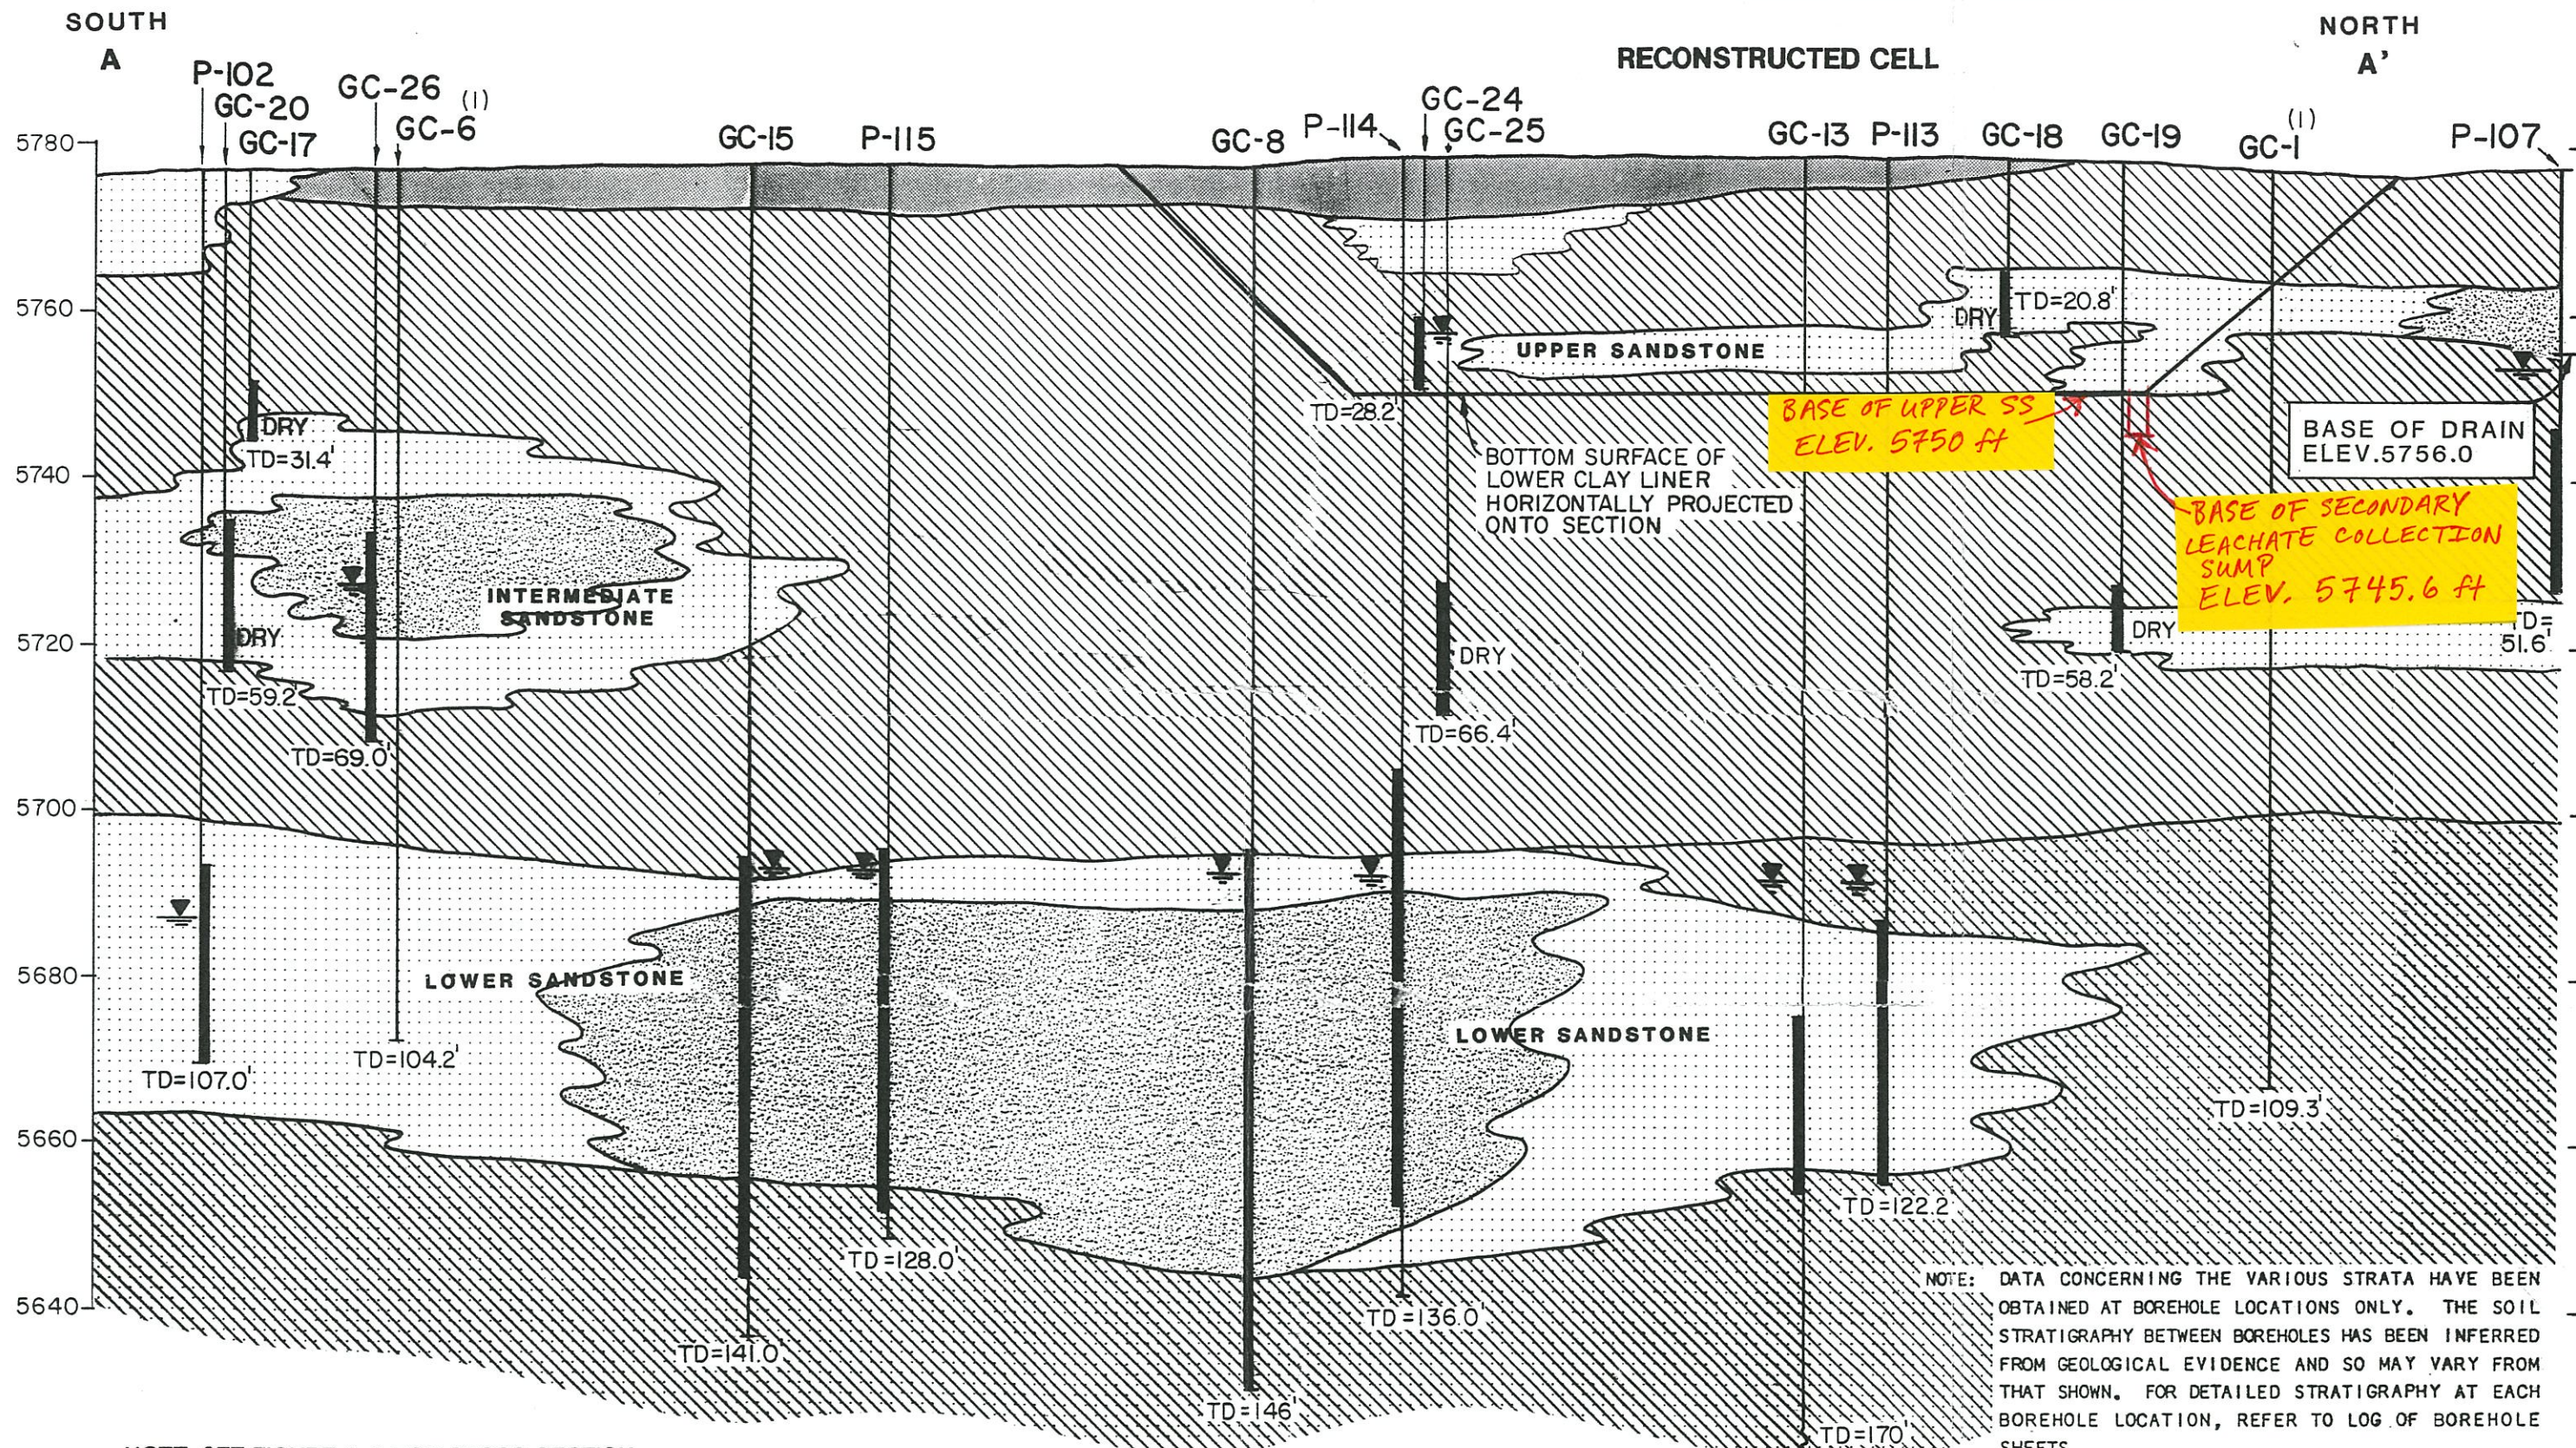
FIGURE **D-9**

WATER LEVEL AS OF 5/8/89

(1) BOREHOLE GROUTED IN MARCH 1984

VERTICAL EXAGGERATION 3X

GEOLOGIC CROSS SECTION A-A'
LOOKING WEST

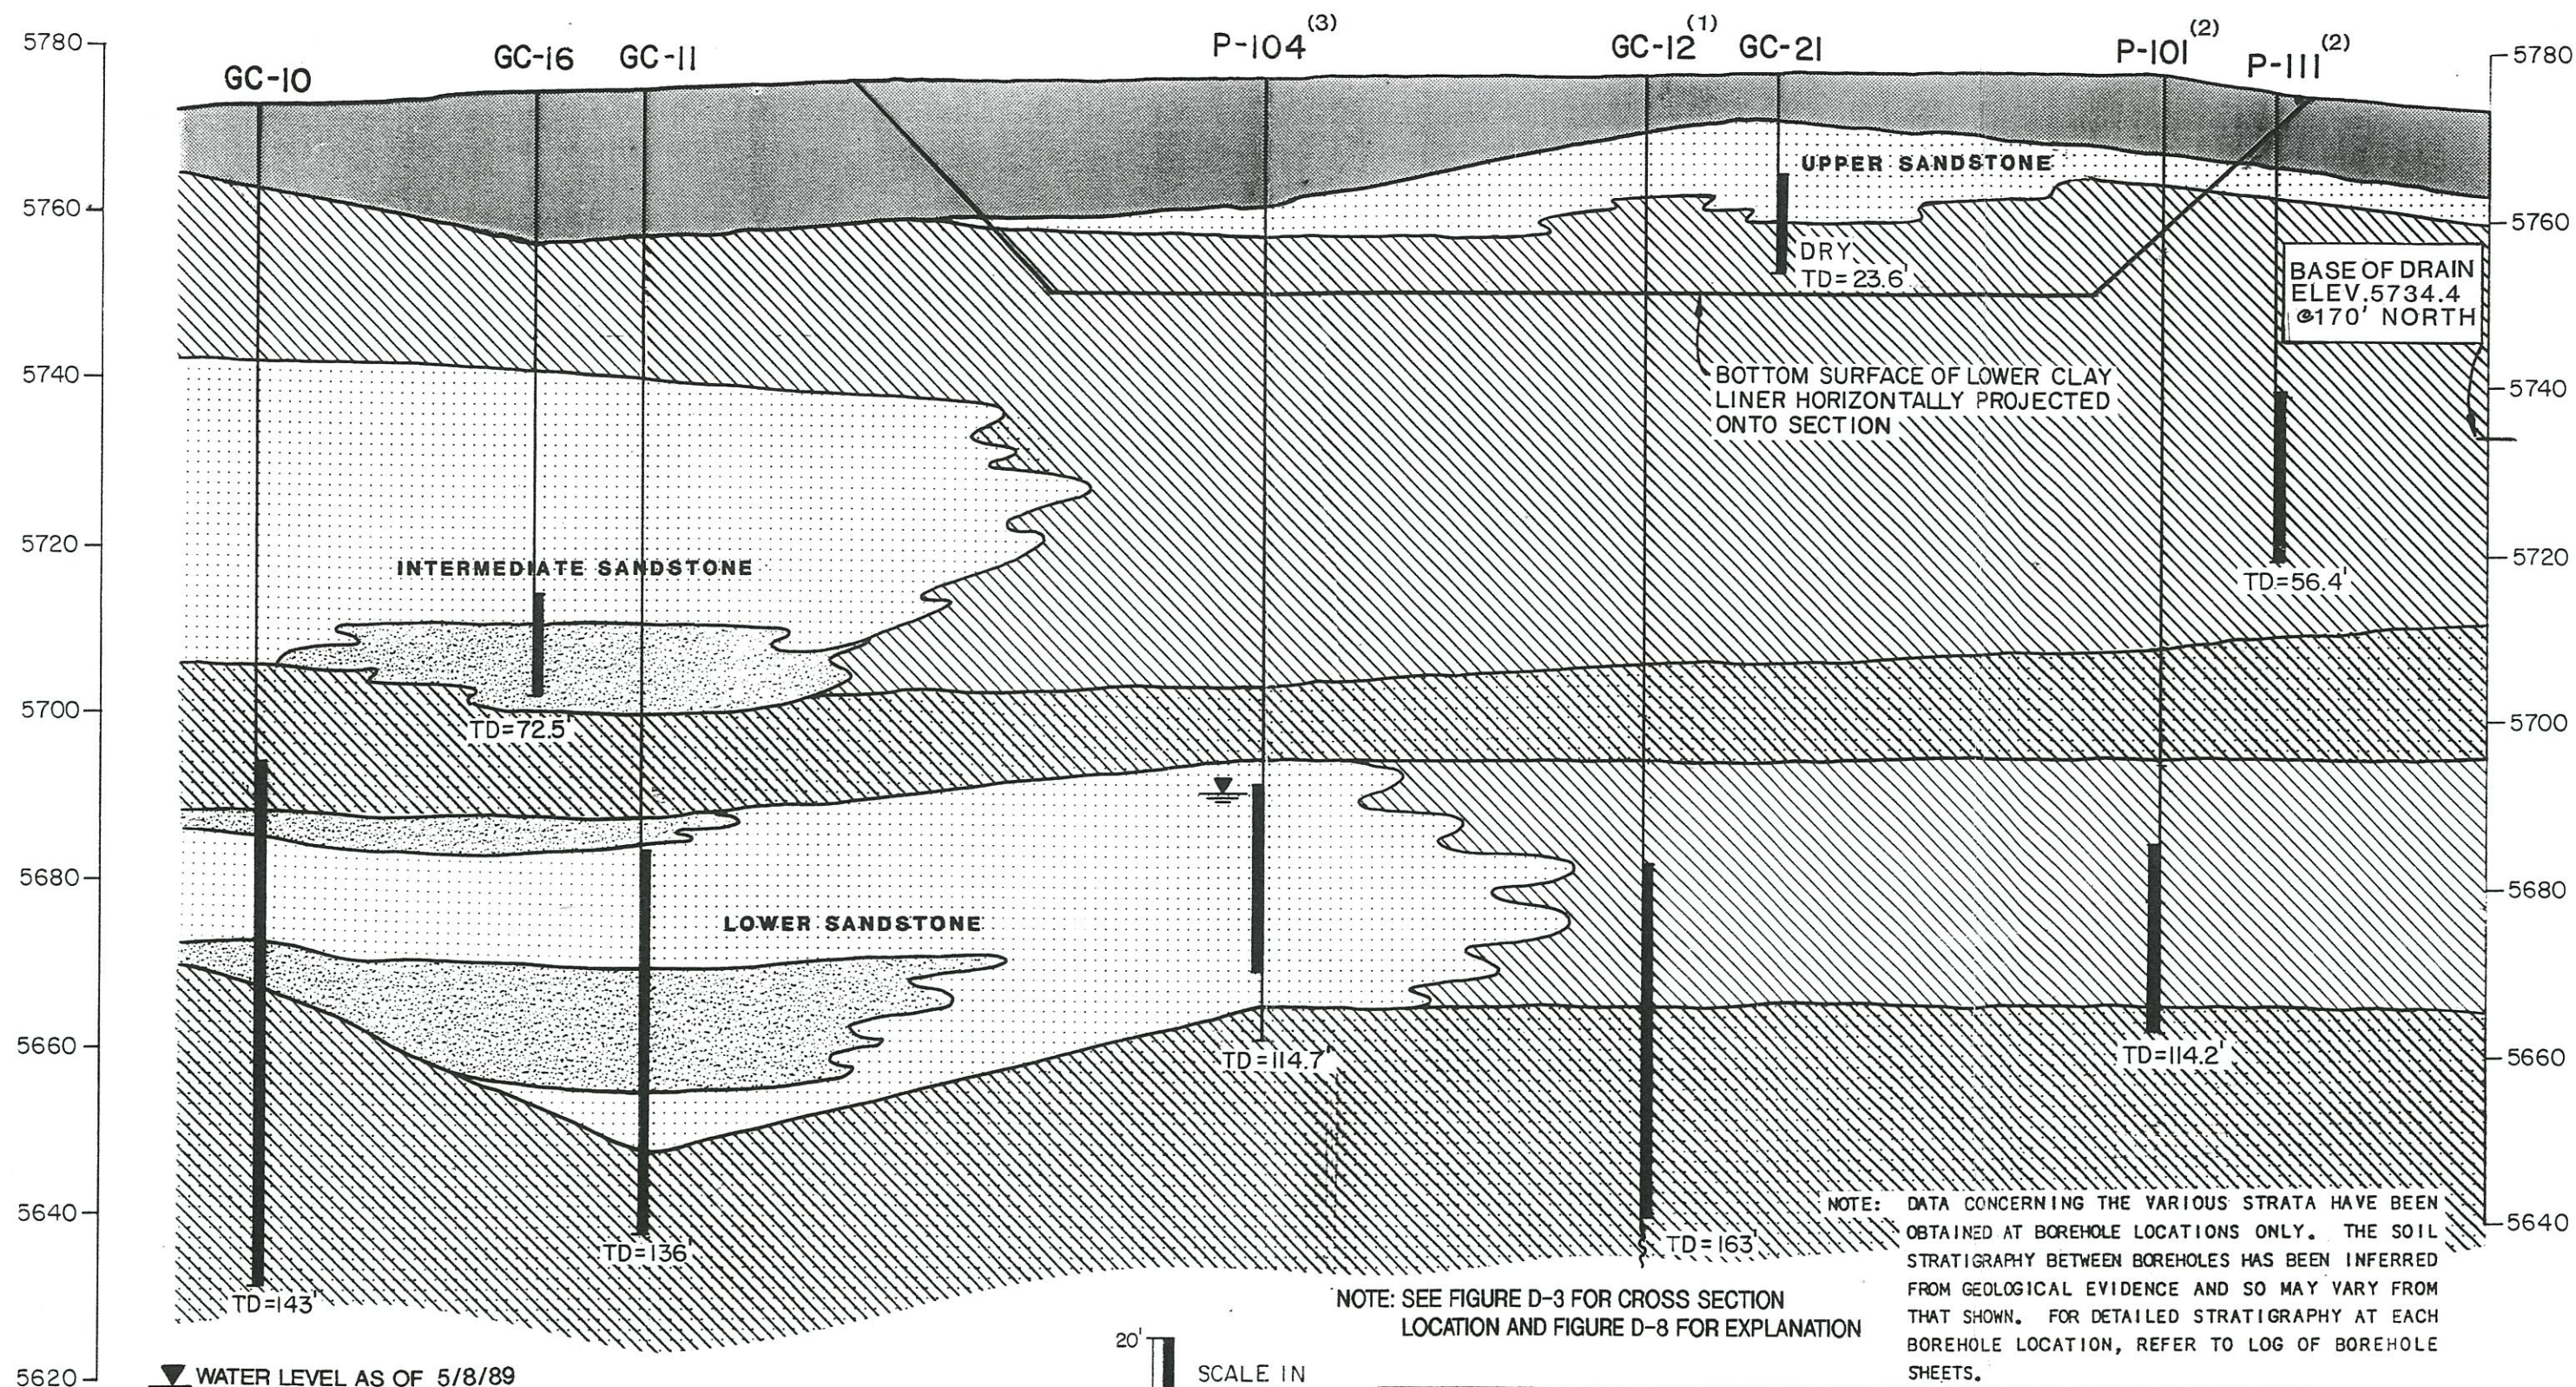
FIGURE
D-10

(1) N.R.: NO READING. PIEZOMETER UNDER REPAIR
(2) WELL DECOMMISSIONED DURING 1/26 TO 2/1, 1988
(3) WELL DECOMMISSIONED ON 8/13/87

GEOLOGIC CROSS SECTION B-B'
LOOKING WEST

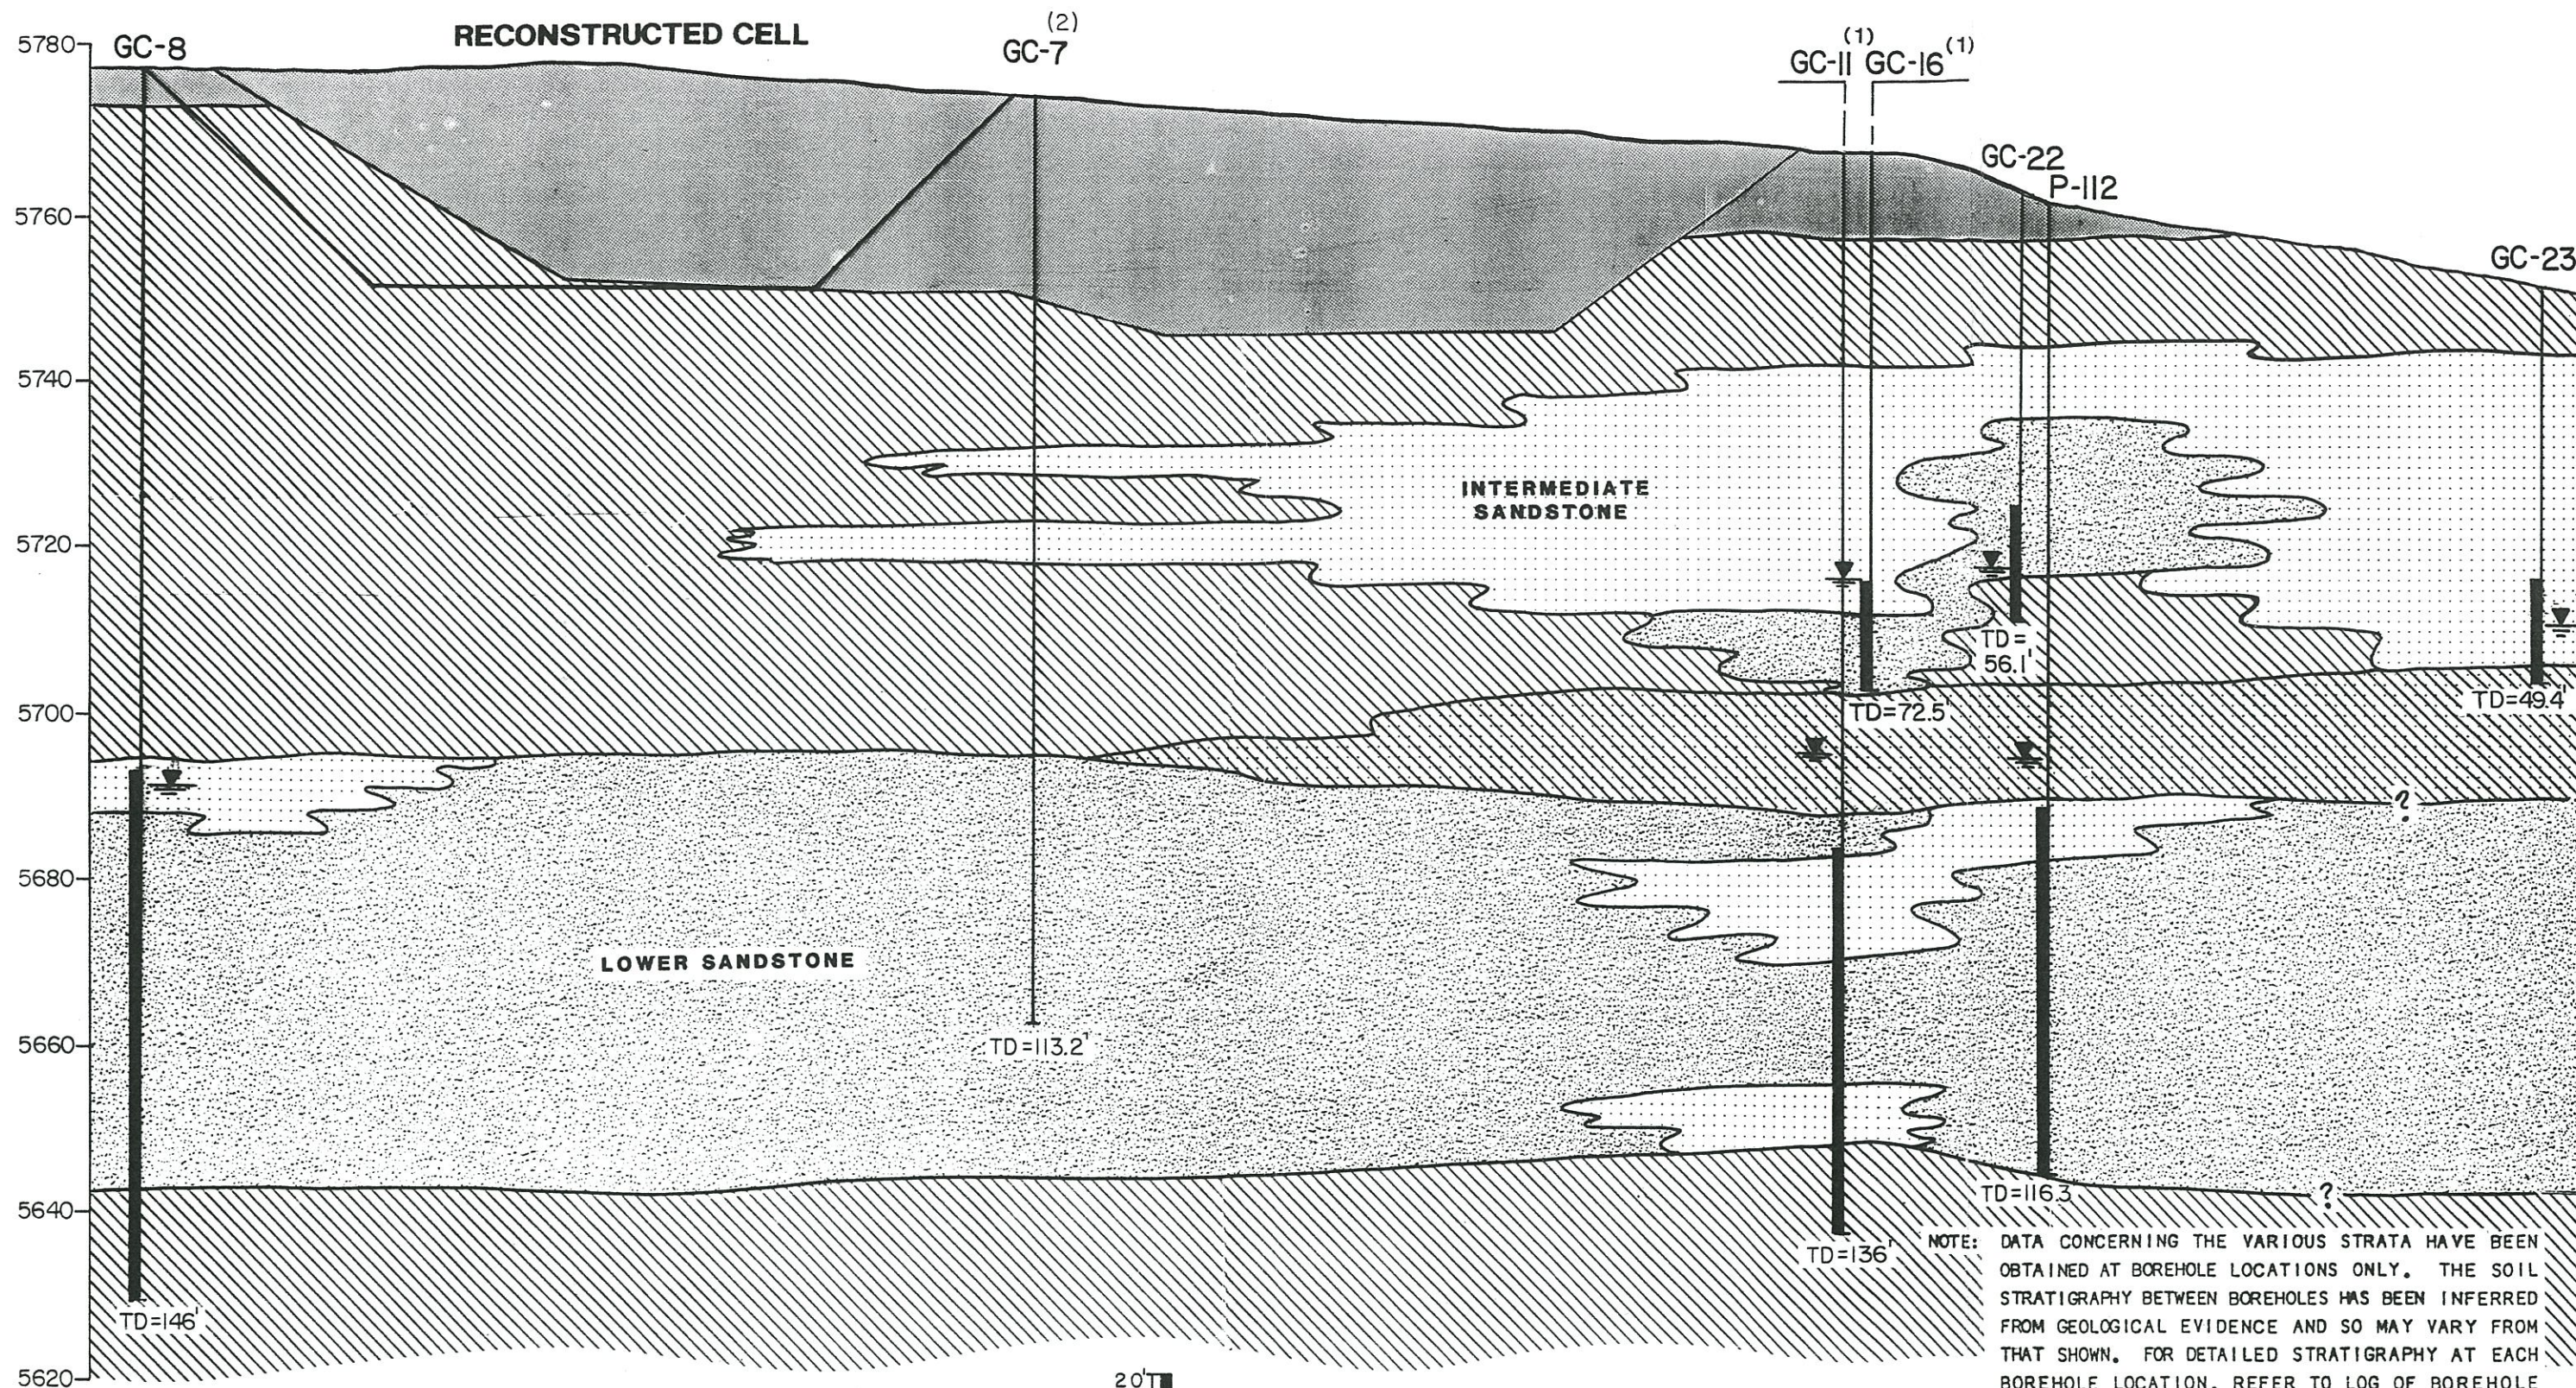
FIGURE
D-11

▼ WATER LEVEL AS OF 5/8/89

(1) N.R.: NO READING. PIEZOMETER UNDER REPAIR

(2) BORING GC-7 GROUTED IN MARCH 1984

VERTICAL
EXAGGERATION
3X

GEOLOGIC CROSS SECTION C-C'
LOOKING NORTHEAST

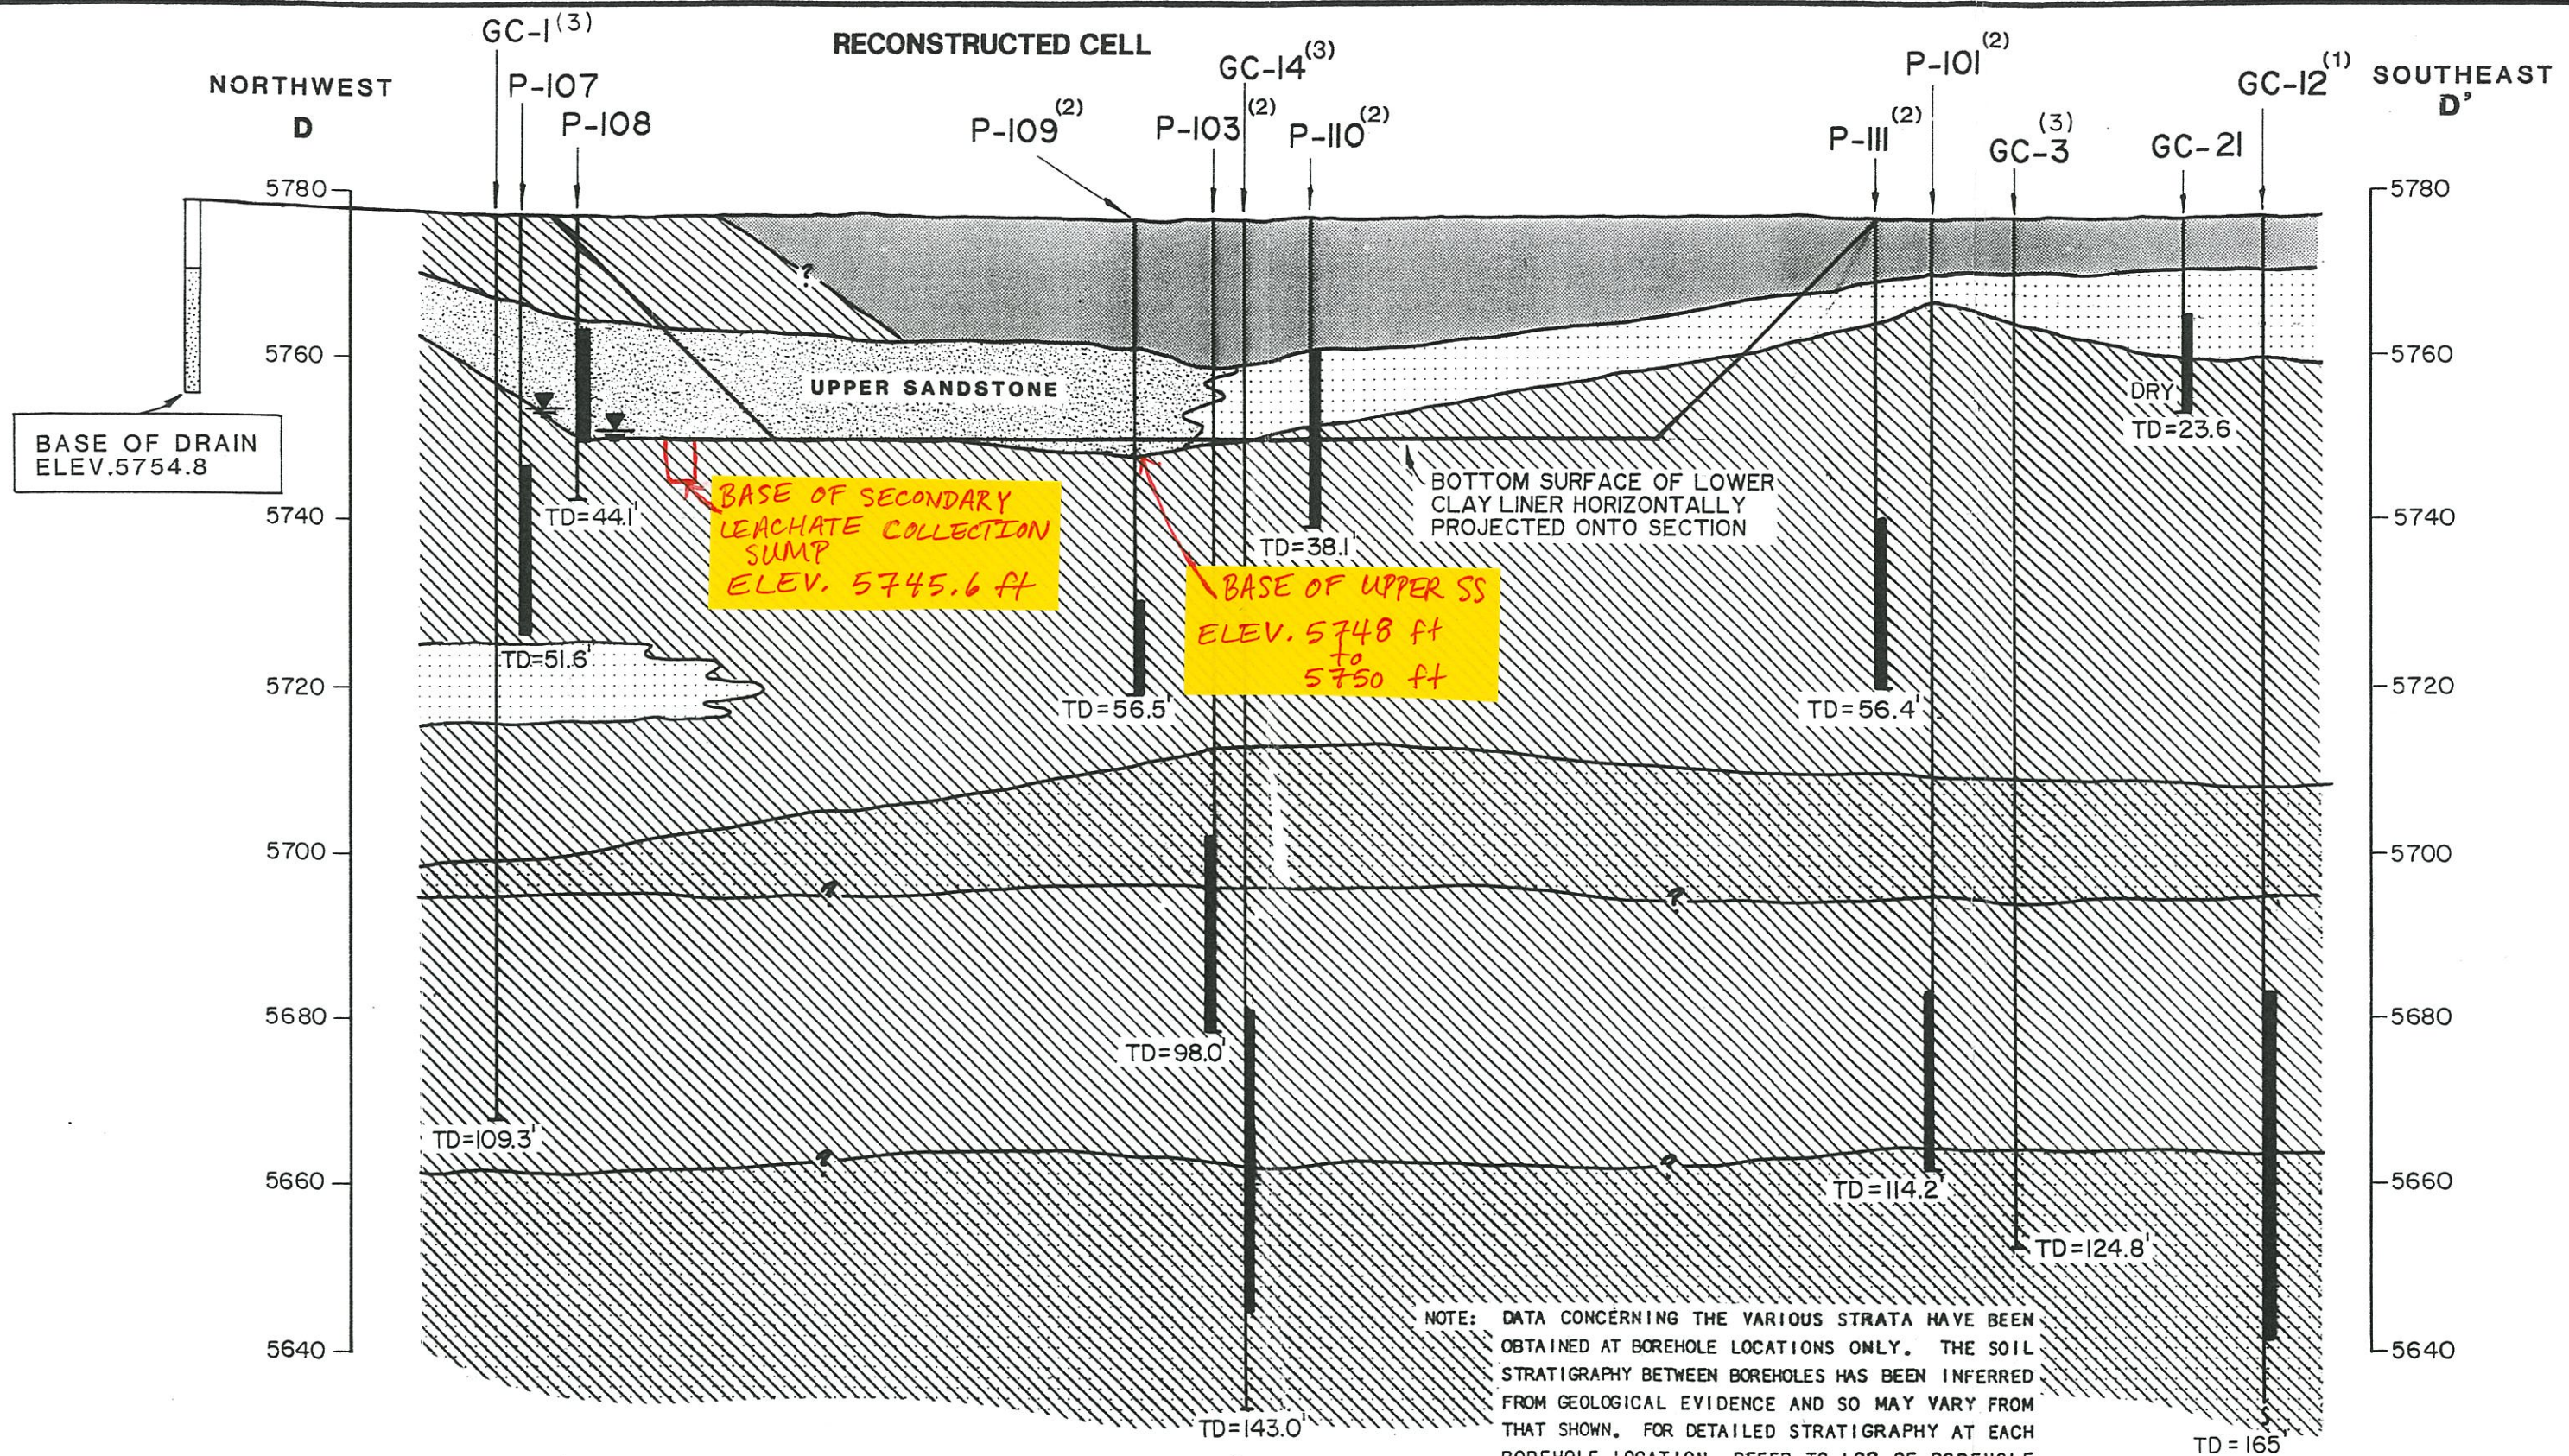
FIGURE D-12

▼ WATER LEVEL AS OF 5/8/89

- (1) N.R. : NO READING. PIEZOMETER UNDER REPAIR
 (2) WELL DECOMMISSIONED DURING 1/26 TO 2/1, 1988
 (3) BOREHOLES GROUTED IN MARCH 1984

VERTICAL EXAGGERATION 3X

**GEOLOGIC CROSS SECTION D-D'
 LOOKING NORTHEAST**
